Technical Report II

900 16th Street

Douglas W. Watson | 16 October 2015
Construction Management | Leicht

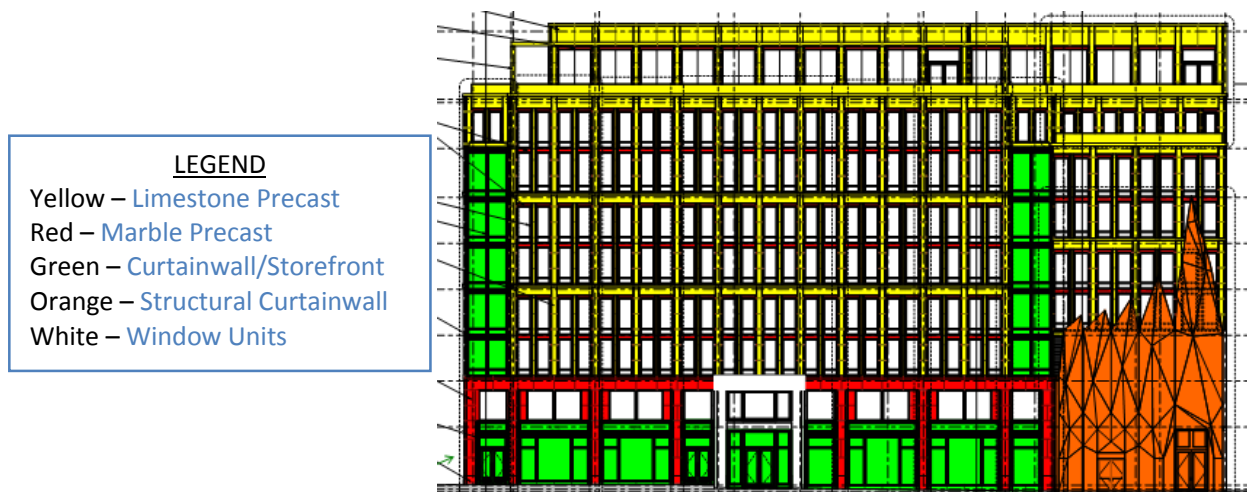
Figure 1: Various Façade Types on East Face

Each panel was picked into place by one of the two cranes on site during this period of the construction. All panels on the South and the West were picked into place by the tower crane that was utilized during the construction of the structure of 900 16th Street. To install the panels on the East face of the façade were picked into place using a separate crawler crane brought in specifically with this process. With a consistently flow of deliveries, each panel was picked directly from the flatbed truck in which it was brought to site on. Although various connection methods are used the main method involves steel plate embeds in both the precast panels and structure. Once in place, a piece of steel angle is bolted to the panel and tack welded in place. While panels in a sequence are being lifted into place a crew of welders use a process referred to as back welding to permanently secure each of the panels in the previous sequence to the building. Following the start of the façade installation the installation of the aluminum punched window units was able to begin. The curtain wall systems located on the Northeast and Southeast corners of the main structure were constructed with a two man crew and the use of a JLG lift. So that flying in the precast panels did not damage the curtainwall system, its construction did not begin until the completion of the panels. The final part of the façade to begin construction is the 3D feature curtainwall system. This highly complex system designed in Germany is being delivered to site on flat beds and is being lifted into place with a truck crane. All the connections are being completed by hand by tradesmen on a JLG lift. The West façade features an Exterior Insulated Finishing (EIFS) system. This system is connected to exterior sheathing fastened to 6” metal studs. All of the EIFS system was constructed using a swing stage scaffolding system.

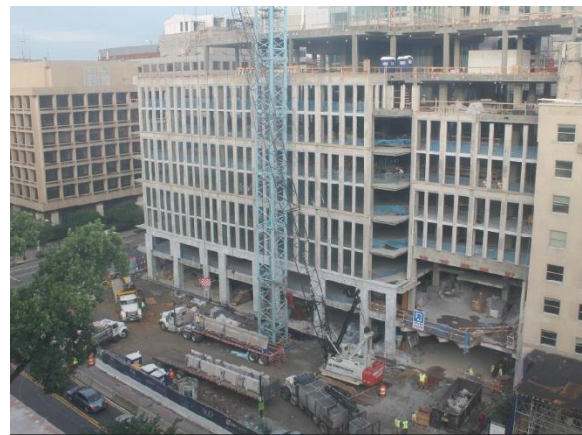
Figure 2: Site Congestion

When looking at the utilization of space on site and the various systems that were used to complete this process I believe that it was very efficient. The South, East, and West facades were all being worked on at the same point in time and were completed on nearly the same dates. While there were many aspects of the positioning of material and equipment that allowed for a good flow of work, there is still room for improvement. The most important thing with a site located in the heart of a city is unimpeded site access and egress. Throughout the entire process the crawler crane never became an issue, but the flat beds occasionally did (as seen in Figure 2). While it can be argued that the weight of the panels does not allow the flat beds to be further from the crane, it was possible to remove the panels from the flat bed and place them in a staging area. In doing so site access and egress could have been cleared so that deliveries for other trades could be more easily received. During the installation of this system the primary entrance to the site is cut off by the crane (shown in Figure 3). At this stage in the construction process the only deliveries that the crane location poses a threat to is curtainwall deliveries. Almost all other deliveries are coming in on box trucks and have the capacity to enter an exit through a single gate. It may have been possible to set the crane up parallel

to the structure so that the primary entrance could have remained open.

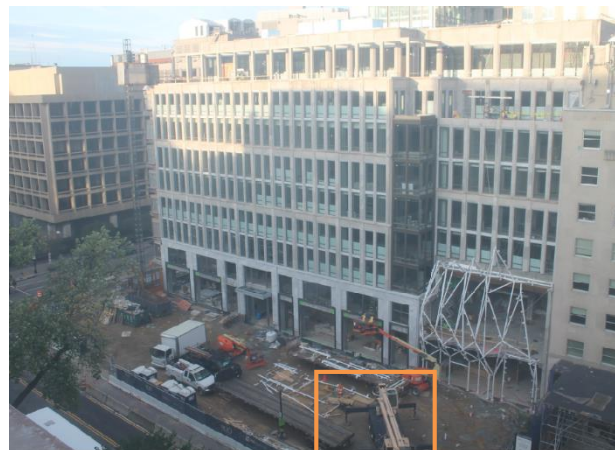
Figure 3: 3D Curtainwall Crane Location

Following the completion of the precast, EIFS, and curtainwall systems both cranes were dismantled and removed from site. At this point a truck crane was brought onto the site to be used for the erection of the 3D structural curtainwall system at the entrance of the church. The location of this system caused the site access to tighten significantly (shown in the third site plan in Appendix C). The positioning of the crane blocked the main access to the site making it more difficult to receive deliveries.

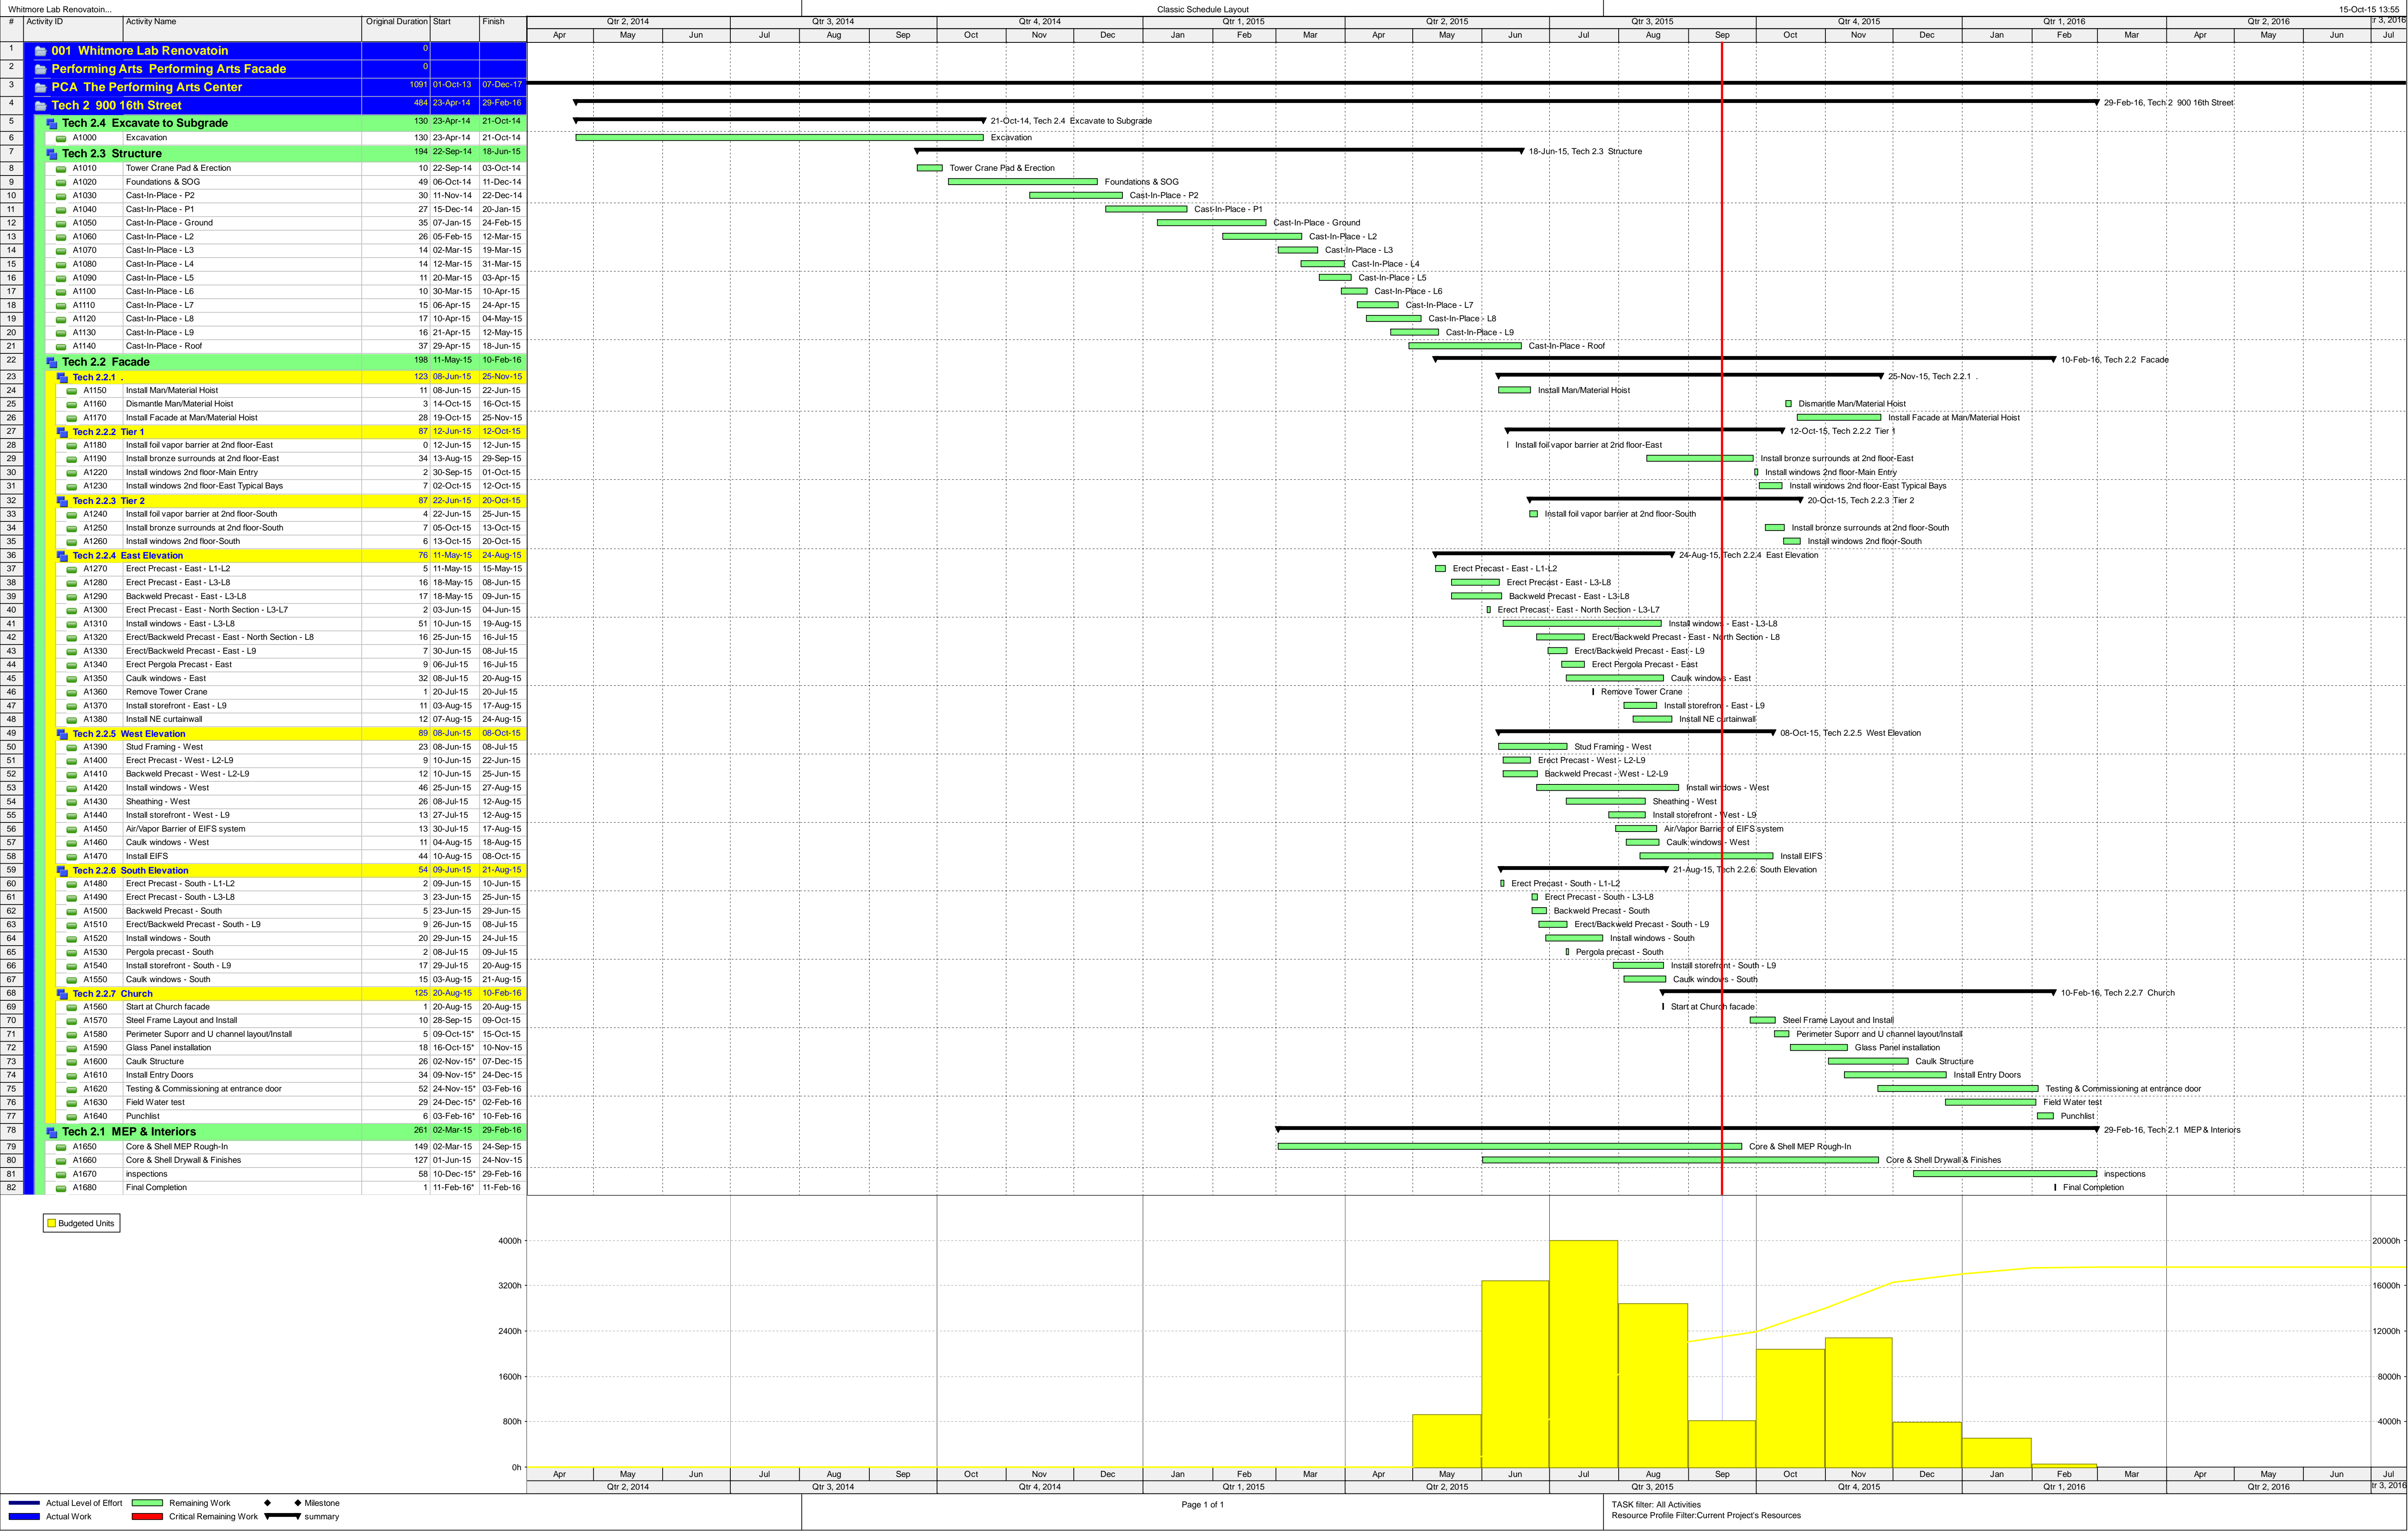
Detailed Production Schedule

The construction of the façade is key to the completion of all interior work because without the enclosure the building is open to the elements. Prior to beginning the façade it is necessary that the entire structure be complete so that all of the precast panels can be received. Timely completion of the façade is key to getting the building dried in. When the façade is nearing completion the interior trades can be released to close out the project.

Construction of the East façade began on the street level of the South portion and began to move northward. With the tower crane just of the East façade precaution needed to be taken when pieces of precast were being erected in that area. Once those panels were in place the crawler crane was relocated to the North end of the site, switching places with the laydown areas. The erectors of the precast panels, EE Marr, typically ran a crew of 1 Superintendent, 1 Foreman, 6 Certified Welders, and 1 Rigger. The number in the crew varied occasionally depending to the amount of work that needed or could be completed on any given day. Using this crew set up the subcontractor was able to install all of the precast panels in 44 days. The curtainwall system located in the Northeast and Southeast corners of the building were constructed by a crew of 3 using a JLG lift to assist them. A crew of 5 tradesmen was tasked to construct the 3D curtainwall system.
